Diamond Drill

WARNER

<u>MINE NAME:</u>	Warner	<u>CONGRESSIONAL LOCATION:</u>	NE1/4 NE1/4 S16 NW1/4 NW1/4 S15 SE1/4 S9 T44N R33W	<u>PRODUCTION DATES:</u>	1915-1958
-------------------	--------	--------------------------------	---	--------------------------	-----------

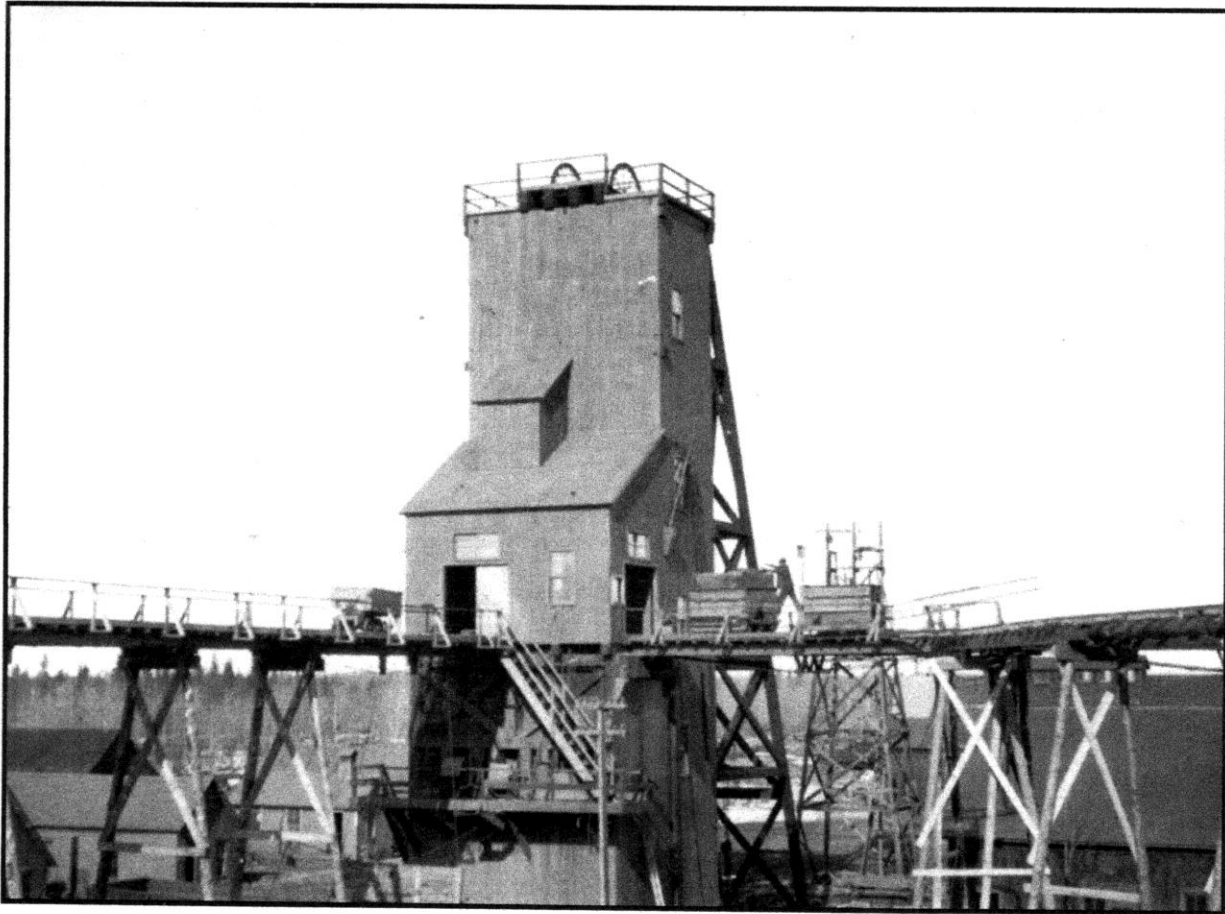
Location: Amasa, Iron Co., Mich. E 1/2 -NW, SW-NE, NE-SW and SE Sec 9; SW-SW Sec 10; E 1/2 NW and NE-NW Sec 15; and NE-NE Sec 16-T44N-R33E. Includes Michigan, NE-NW Sec 9; Gibson, NW-NW Sec 15; former Warner which included SE Sec 9; and Bay Shore, NE-NE Sec 16.

Description: The former Warner as above described was opened in 1915; shipped every year through 1934 except 1932. Operated by Hemlock River Mining Co. (Pickands Mather & Co., Agent) . Lease surrendered to fee owners in 1934. Worked by stoping method. Depth, 1,239 ft., 11th level. Small stock-pile clean-up shipment made in 1937 by L. E Ives, Inc. The former Warner together with the Michigan and Gibson and adjacent tracts, were leased by North Range Mining Co. in 1948. Mine pumped out and explored 1949-1950. Equipped for production, 1950. First shipments, 1951.

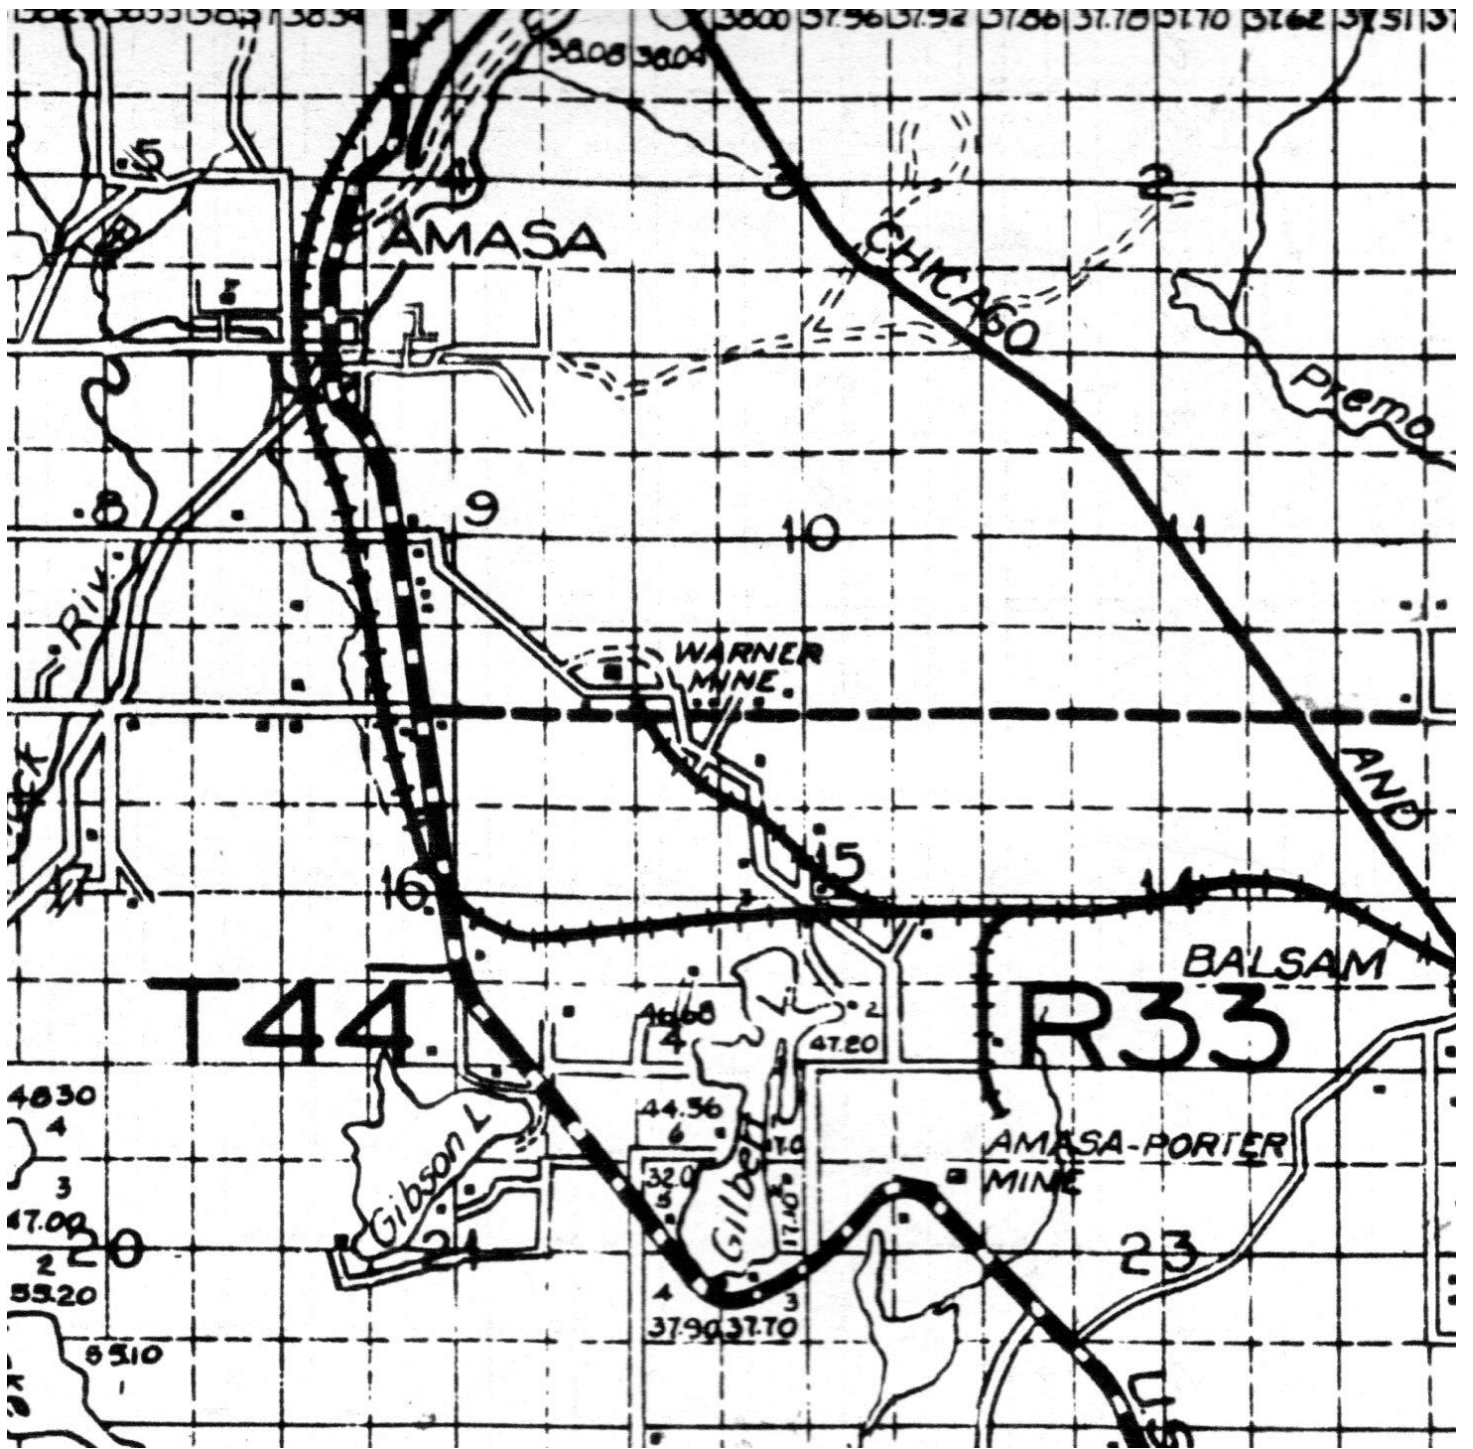
The Warner Mine area is included on plate 1 of 5 of the East Iron County Composite Mine map.

SHAFTS: The Warner Mine is served by three shafts. An exploration shaft was sunk north of the mine workings along the strike of the formation, this is known as the Warner Exploration or the #1 shaft. The #1 shaft is covered under the name of the Warner Exploration.

The #2 shaft served as the main production shaft until ground conditions rendered it unsuitable for use. The #3 shaft was then sunk to replace it as the production shaft. The other shaft on this site is an air shaft.
